Waste Management in Antarctica

2006 Workshop Proceedings

Proceedings of the 2006 workshop held by the
COMNAP Antarctic Environmental Officers Network (AEON)
on Monday 10 and Tuesday 11 July 2006

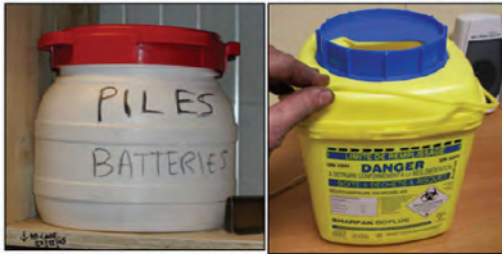
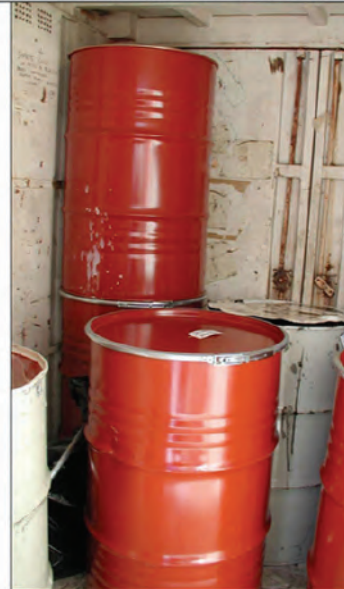
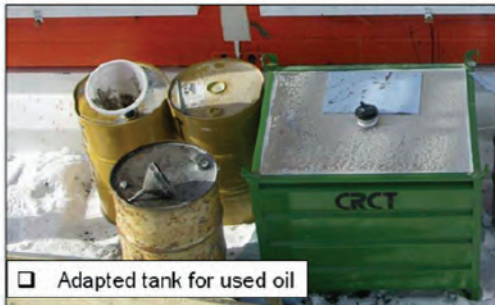
Figure 4: Special containers for specific wastes

Objectives : To find resisting, easy to store, move and to be loaded, adapted packaging

Special boxes for batteries, medical waste

Special drums for selected waste

Adapted tank for used oil

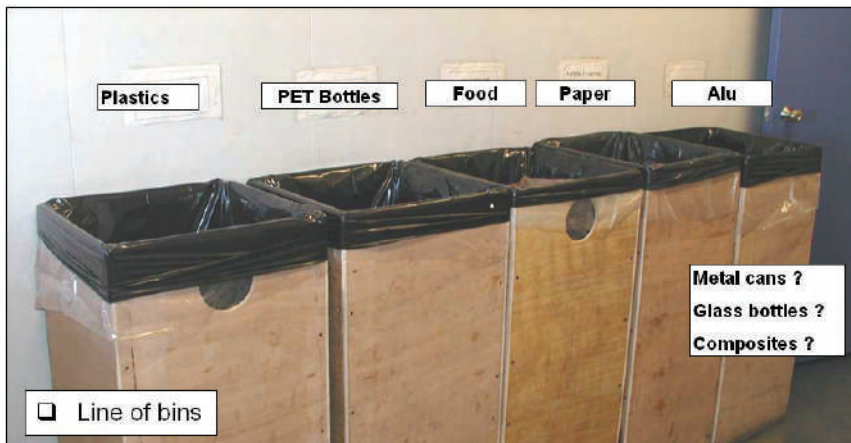
Figure 5: techniques to avoid further sorting

Glass bottles

- Green
- White
- Brown
- Non broken bottle

Line of bins

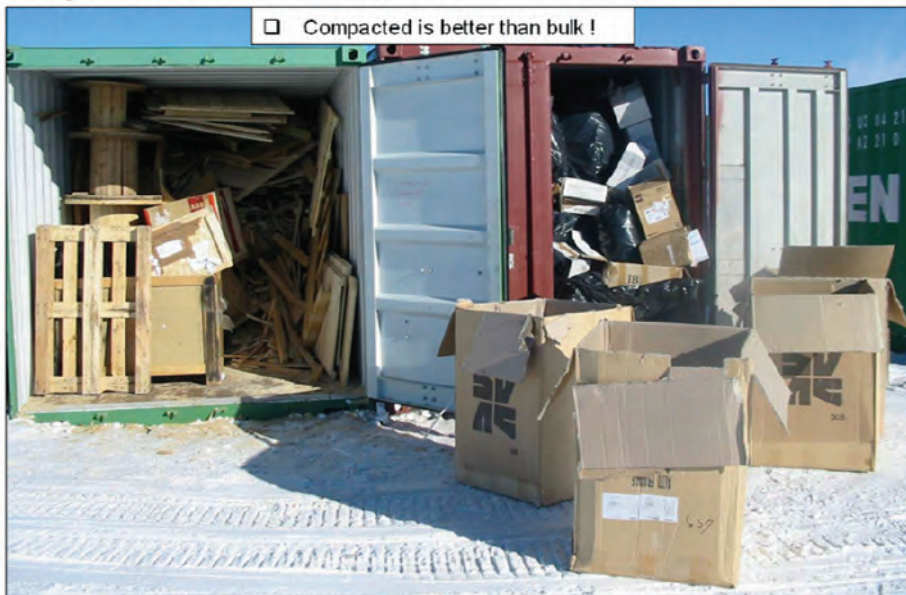
Figure 7: Avoid badly packed containers

❑ Objectives : to avoid this

❑ Compacted is better than bulk !

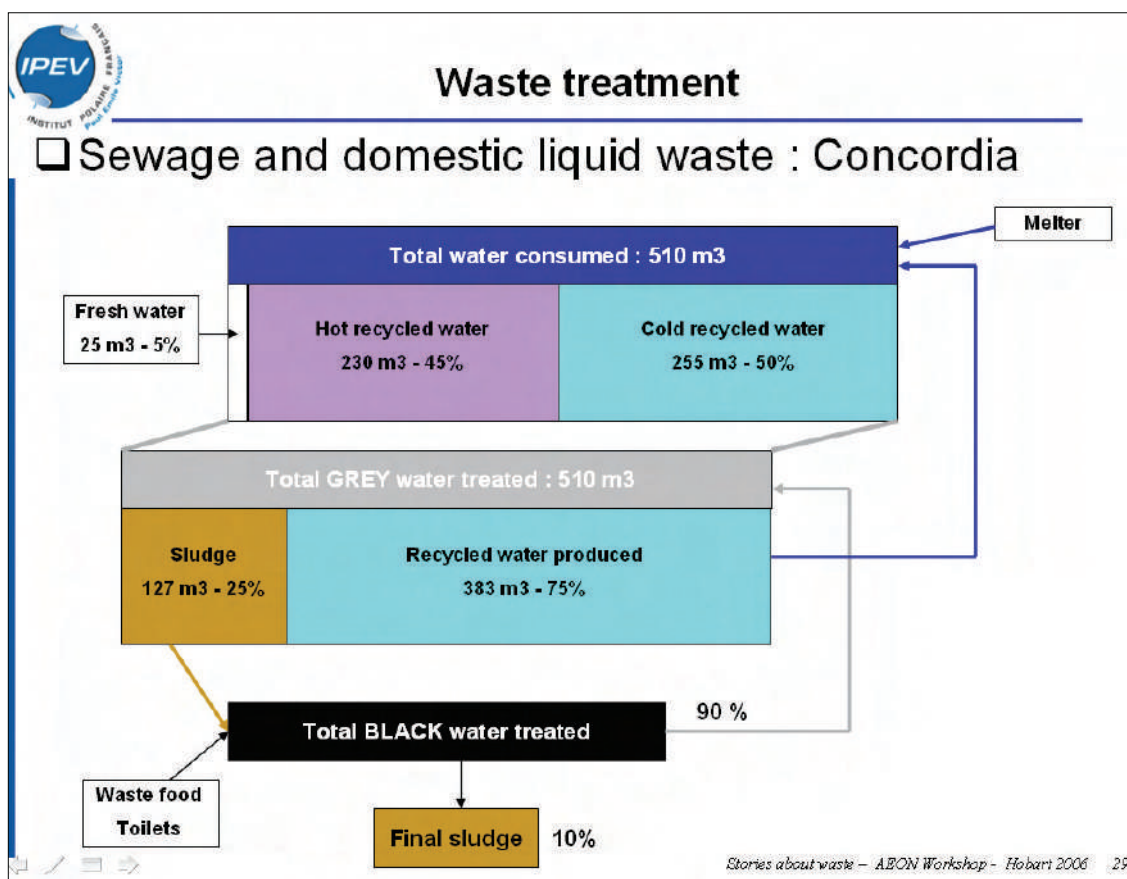
The diagrams on the following pages show figures relating to the treatment of grey water at Concordia:

Figure 8: Volumes of Sewage and Domestic Liquid Waste

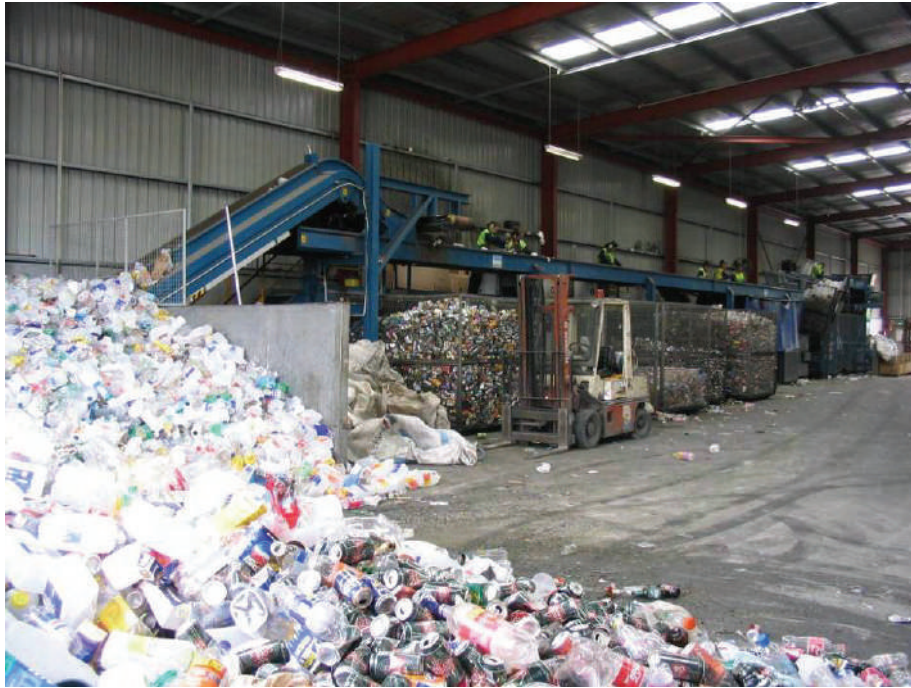
*Figure 2:
Recyclables
can be
received co-
mingled from
Antarctica for
sorting in the
Collex / Veolia
recycling
facility in
Hobart*

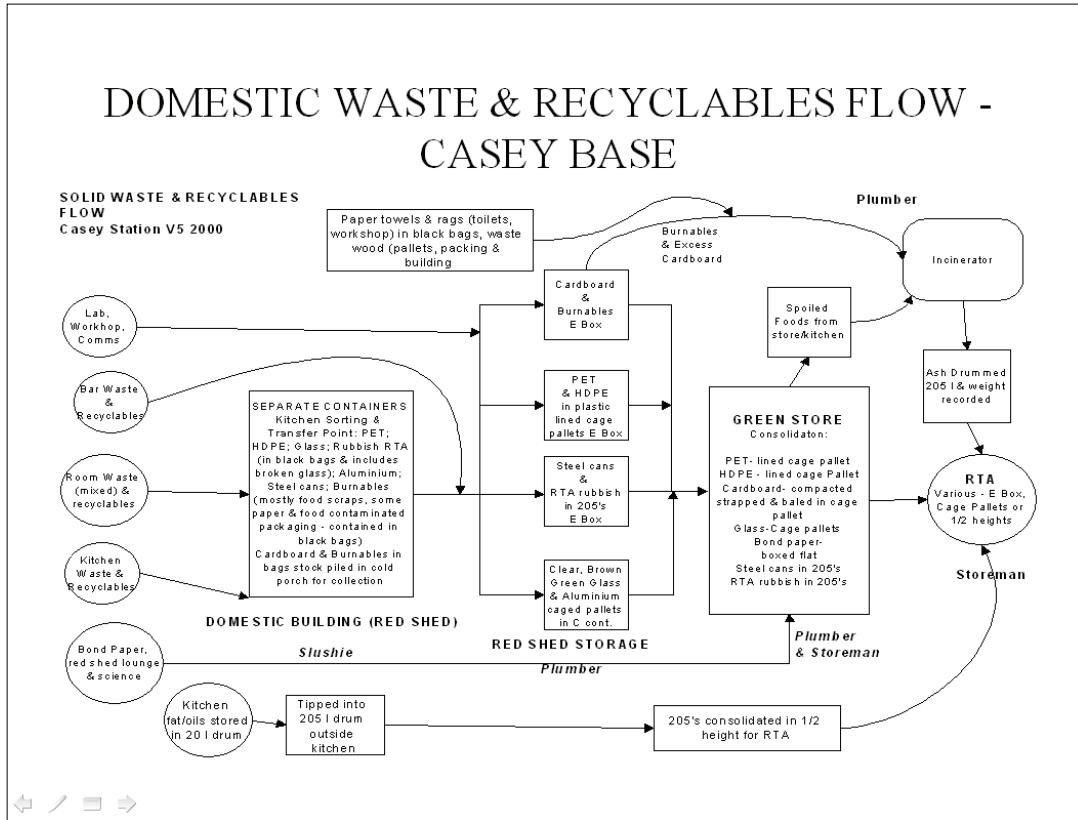
Figure 3: Waste and Recyclables flow at Casey Station

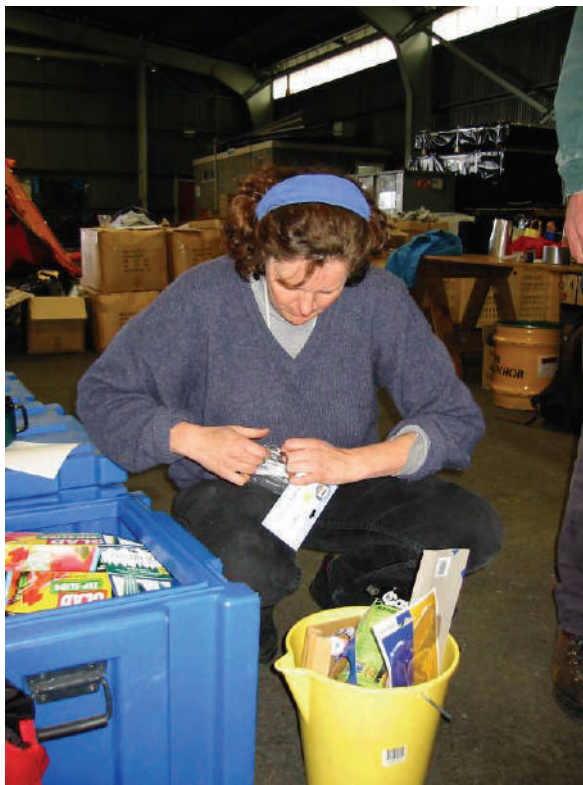
Figure 1: removal of excess packaging prior to deployment in the field

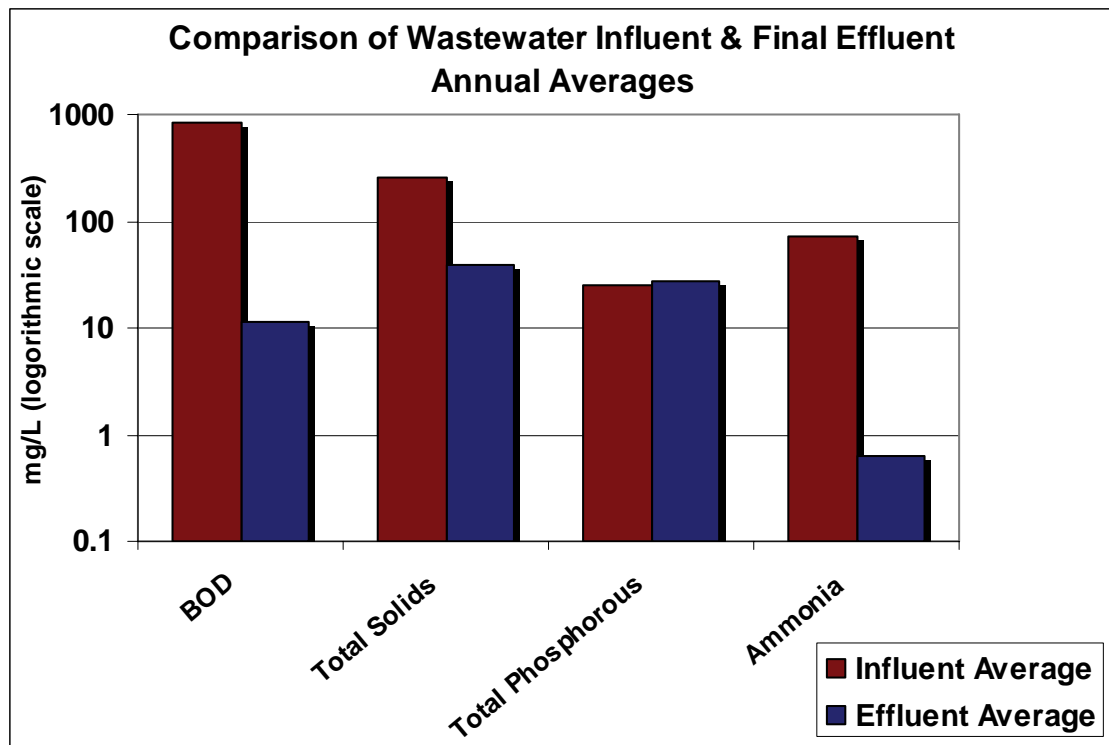
Figure 2: Benefits of wastewater treatment process. Note: Biochemical Oxygen Demand (BOD) is a measurement of organic content in the water that consumes dissolved oxygen.

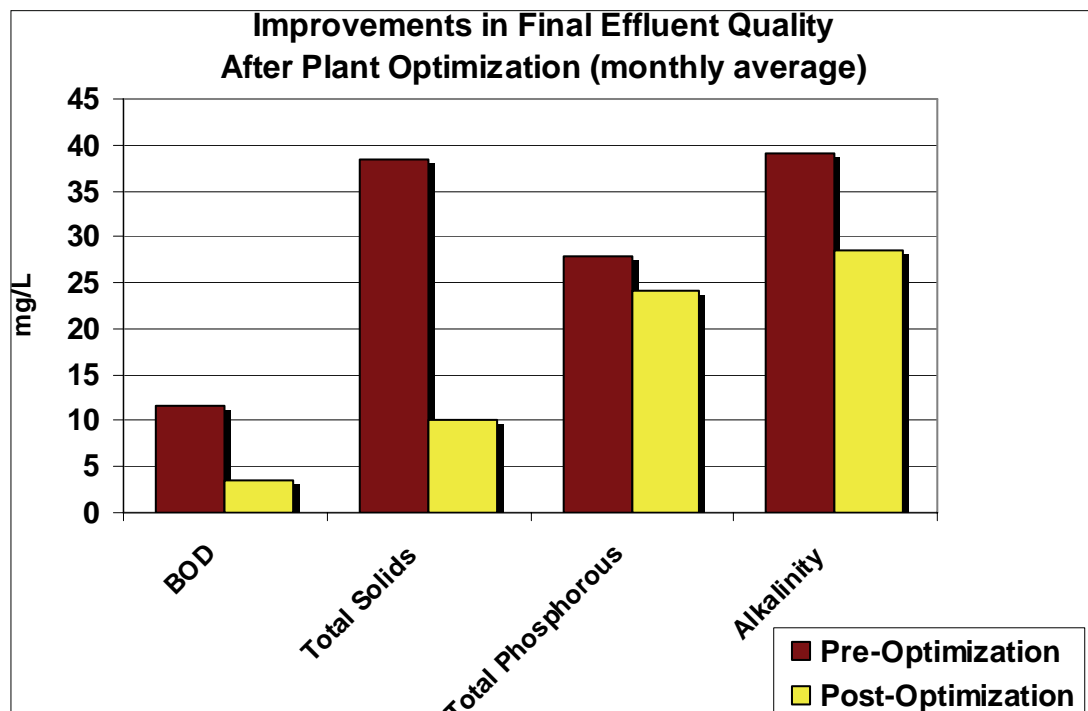
Figure 3: Plant performance improvements from November 2005 (pre-optimization) and December 2005 (post-optimization)

The original design for the plant recommended the use of single stage centrifugal blowers. This design was later modified within RPSC and is an example of the need for a DBO plan. While the diffusers do create excessive turbulence, corrective action has been taken and currently additional air is blown off into another basin.

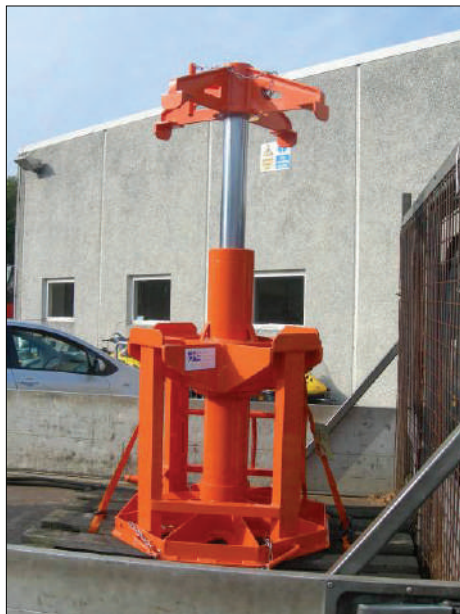
BAS has trialled a number of options for reducing the volume of empty drums, to fly them out from the field. In 2006, we worked closely with a local engineering firm to develop a portable, light-weight drum crusher for use at remote field sites. The prototype meets the following specifications:

- A machine that can crush a 45 gal. fuel drum to approx 20 % of original volume;
- Crushed drum must be safe to handle manually and safe for air transport;
- Weight must be less than 200 kg, and it must break down into component parts of less than 80 kg;
- Width must not exceed 1m to fit inside the door of a Twin Otter aircraft;
- The hydraulic power pack must run on a small portable petrol generator;
- The crusher must work at temperatures of –20 °C; and
- Fuel dregs must be captured on crushing to allow for proper disposal.

Figure 2: Drum crusher prototype

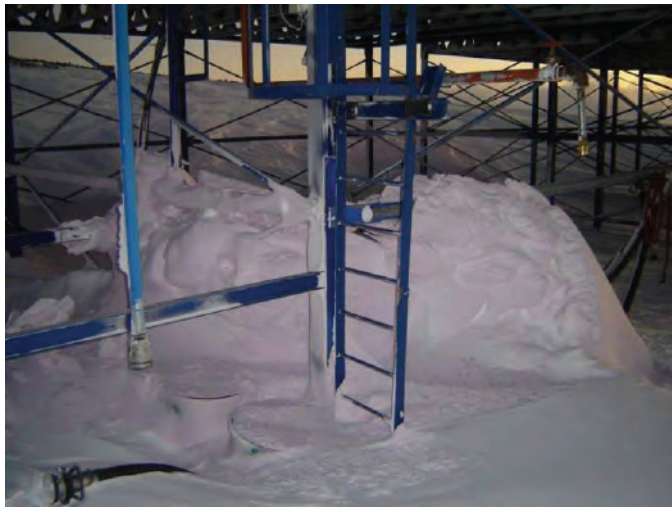
Figure 1: Initial reported fuel spill

A fuel spill at the SANAE IV Base reported on 16 July 2005, initially incorrectly suggested a spill involving approximately 100 000 litres. The cause of the spill (human error) was investigated during the 2005-6 summer season. After thorough calculation, the spill was found to not have exceeded 20 940 litres. A partial (approx. 50%) clean-up of the effected area was undertaken immediately by the over-wintering team during the year. During the past summer season, a dedicated team continued the clean-up effort. A third and final clean-up

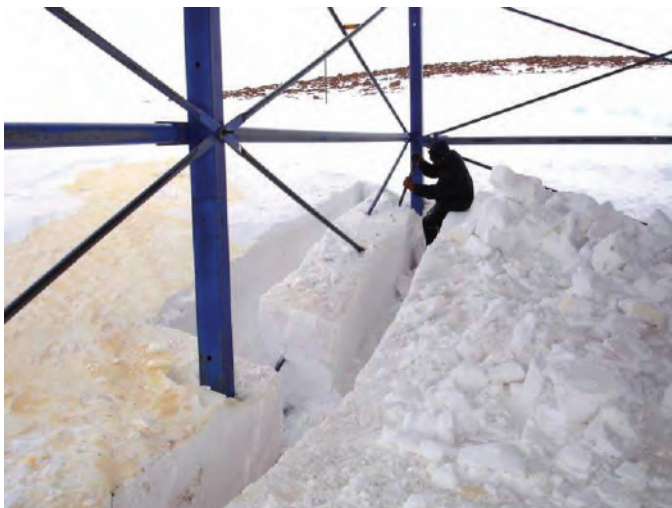
Figure 2: trenches being dug in the contaminated area of the spill

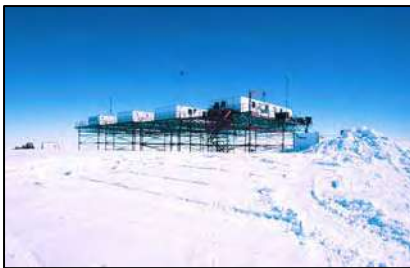
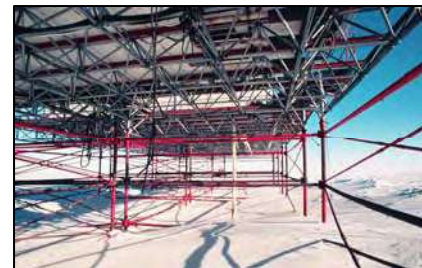
Photo of E-Base - year 2000

The base was constructed on top of steel pillars supporting a floor structure comprising of integrated steel space frames. The main buildings comprised of four modules from North to South orientation respectively:

- Power shack and ablution facilities
- Recreation and kitchen area
- Accommodation and hospital
- Accommodation and communication facilities

Due to the glacier movement and also taking into account the anticipated life expectancy of E-Base. An EHS Audit was compiled during the 2001/02-relief voyage to determine the feasibility of maintaining E-Base as a logistical platform. The conclusion of above audit was that E-base had suffered structural damage due to glacier movement and that it would not be financial viable for SANAP to maintain E-Base as a platform. Recommendations were made for E-Base to be removed.

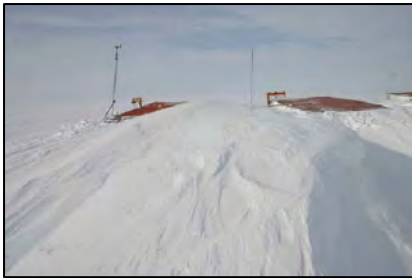
Photo 3 - year 2005

Large Sastrugis stretch from the western end of all the zones and reach as high as the roof in most areas. There is also substantial accumulation between the buildings e.g. the western side doors are all completely covered.

Photo 3 - Illustrates the snow accumulation on the western side of the on Power shack / ablution facilities and Recreation / kitchen area.

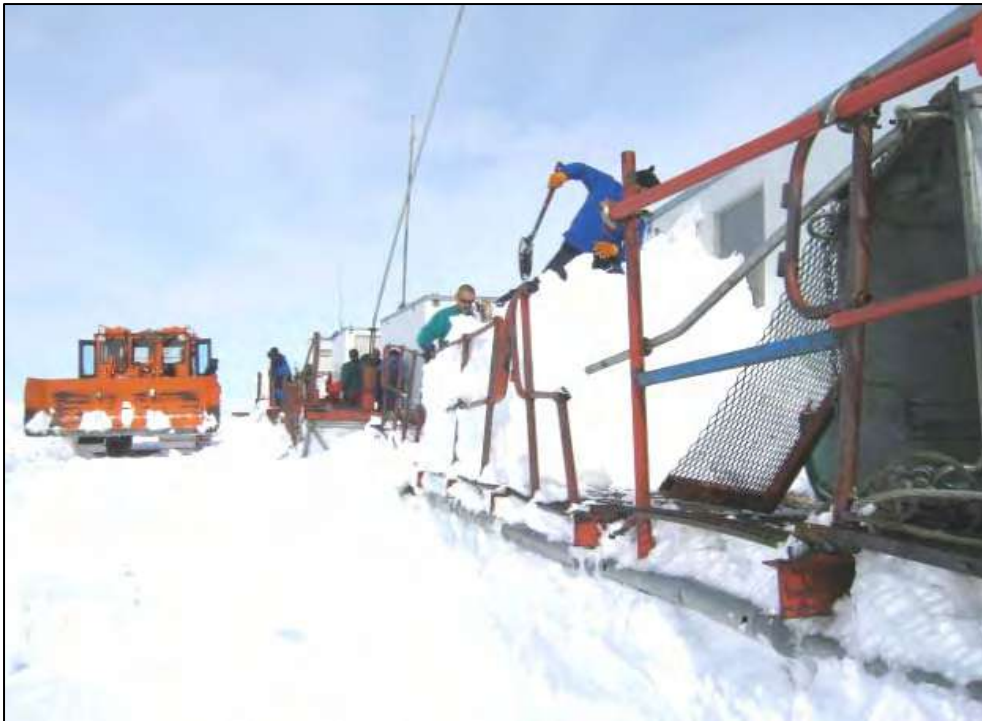
Photo 9 – 27th December 2005

In preparation for the decommissioning of E-Base the eastern side was levelled to approximately one meter below the steel walk way. This action was necessary for the safer handling of heavy vehicles, cargo, sledges and any other activity in and around E-Base.

- The Eastern side of E-Base was cleared of ice and snow accumulation to approximately one meter below the walkway (illustration photo 9).
- Access points to the temporary accommodation and communication facilities were cleared.
- A black bag system for human waste was installed.
- General waste drums were placed in strategic positions on top of the walkway.
- The E-Base kitchen was temporary used by the chef to prepare meals.

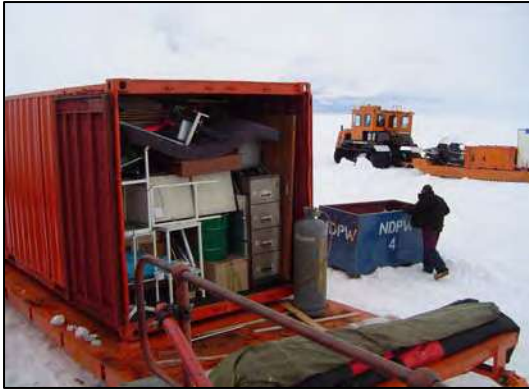
Photo 10 – 28th December 2005

The dismantling of first of the four building commenced on the 28th December 2005. All the furniture, electrical wiring, hospital equipment and fixtures were packed into dedicated containers. In sequent, the interior walls were removed, the roof and finally the main supporting walls, as illustrated below. The entire decommissioning exercise was concluded on the same day.

- On the morning of the 28th December 2006 all movable furniture, fixtures, electrics, piping and dry walls were removed from the sleeping accommodation and hospital building (Block C).
- All abovementioned items were packed into 20-foot transport containers (illustrated in photo 10).
- The decommissioning team started removing the insulated roof panels (illustrated in photo 11).
- The team continued by dismantling the walls and remaining support pillars (illustrated in photo 12).
- All the roof and wall building panels were strapped together and weighed ready for back loading (illustrated in photo 13).
- All metal waste (e.g. roof bolts, railings, PVC piping etc) was placed in recycle bins.
- All plastic novilon flooring was removed.
- Only the wooden floor panels and the steel support structures (space frame) remained behind.

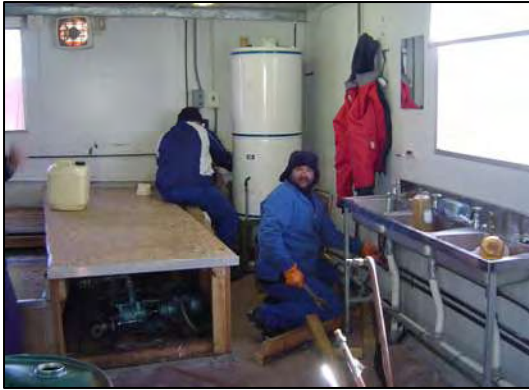
Photo 14 – 29th December 2005

Above photo
All fixtures and electrical wiring / ducting being removed

This building was anticipated to be the most difficult of the four buildings to remove. It contained the ablation block, workshop and two 120 KVA generators (power plants). Due to the extent of the slope (angle) of the building and the stresses on the sub structure; the interior, dry walls and the roof had to be removed before the diesel day tanks and the generators could be loaded onto cargo sledges. Two twenty-foot containers were used to store the removed: fixtures, lubricants, engine parts, E-base maintenance tools, batteries and movables! Note: A minor spill (less than ten litres) of polar diesel was reported during the removal of the generators. The spill was contained and cleaned satisfactory!

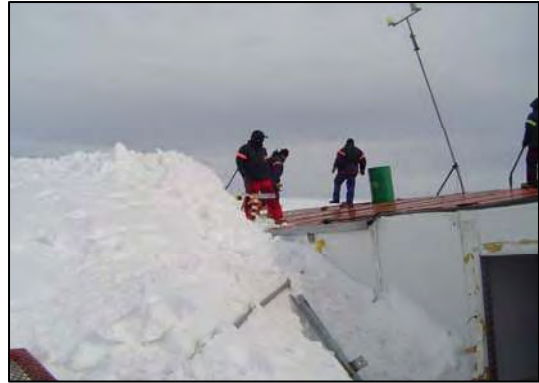
Photo 15 – 29th December 2005

Above photo
Roof being cleared of ice

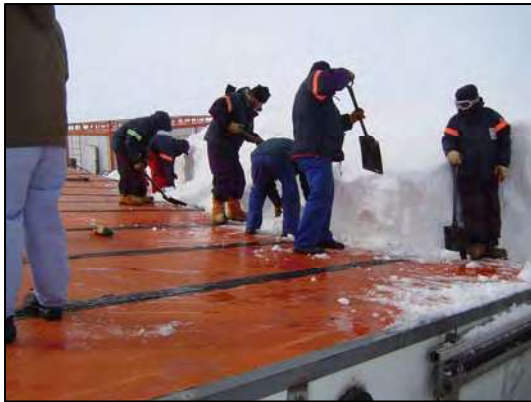
Photo 16 – 30th December 2005

Above photo
Roof being cleared of ice, prior to roof being removed

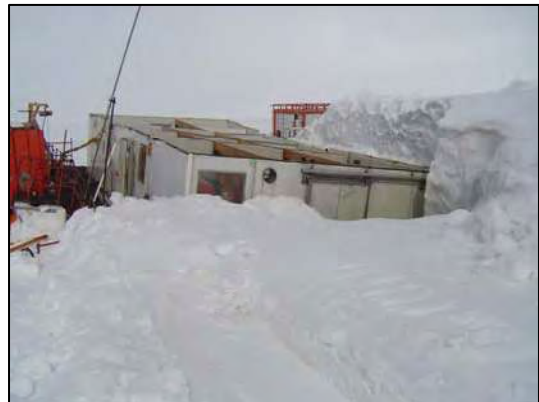
Photo 17 – 30th December 2005

Above photo
Roof removed

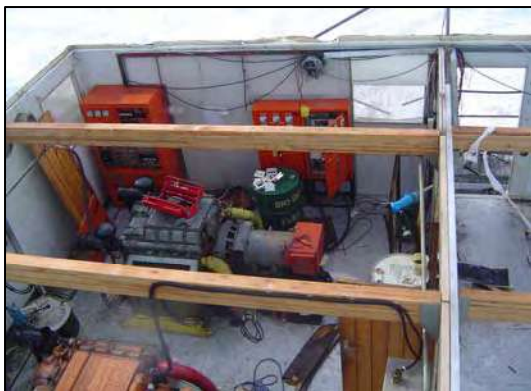
Above photo
View of the power shack with roof removed

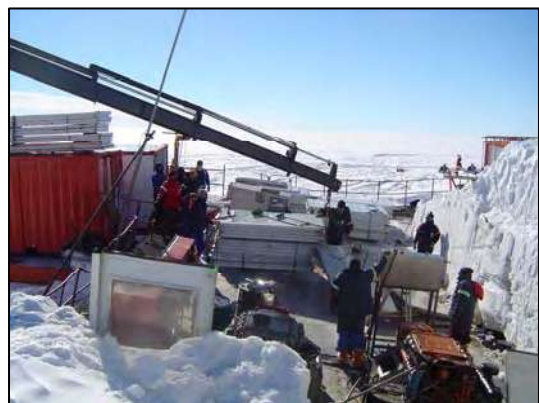
Above photo
The walls of Block A being removed

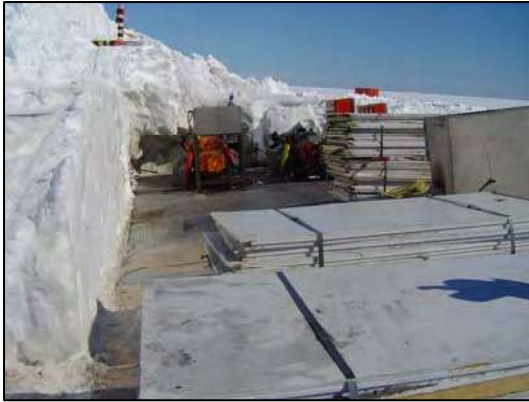
Photo 20 – 31st December 2005

The wall panels being strapped ready for loading onto cargo sledges

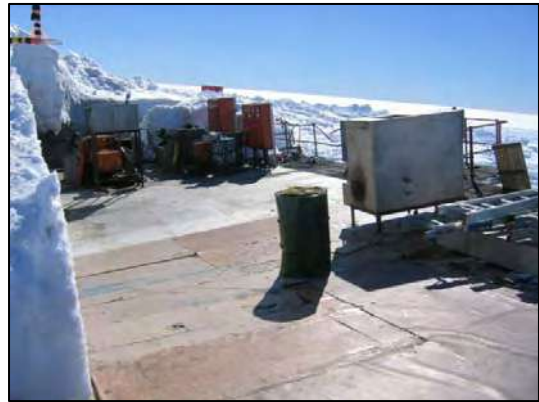
Photo 21 – 31st December 2005

The diesel day tank and generators ready for loading onto cargo sledges

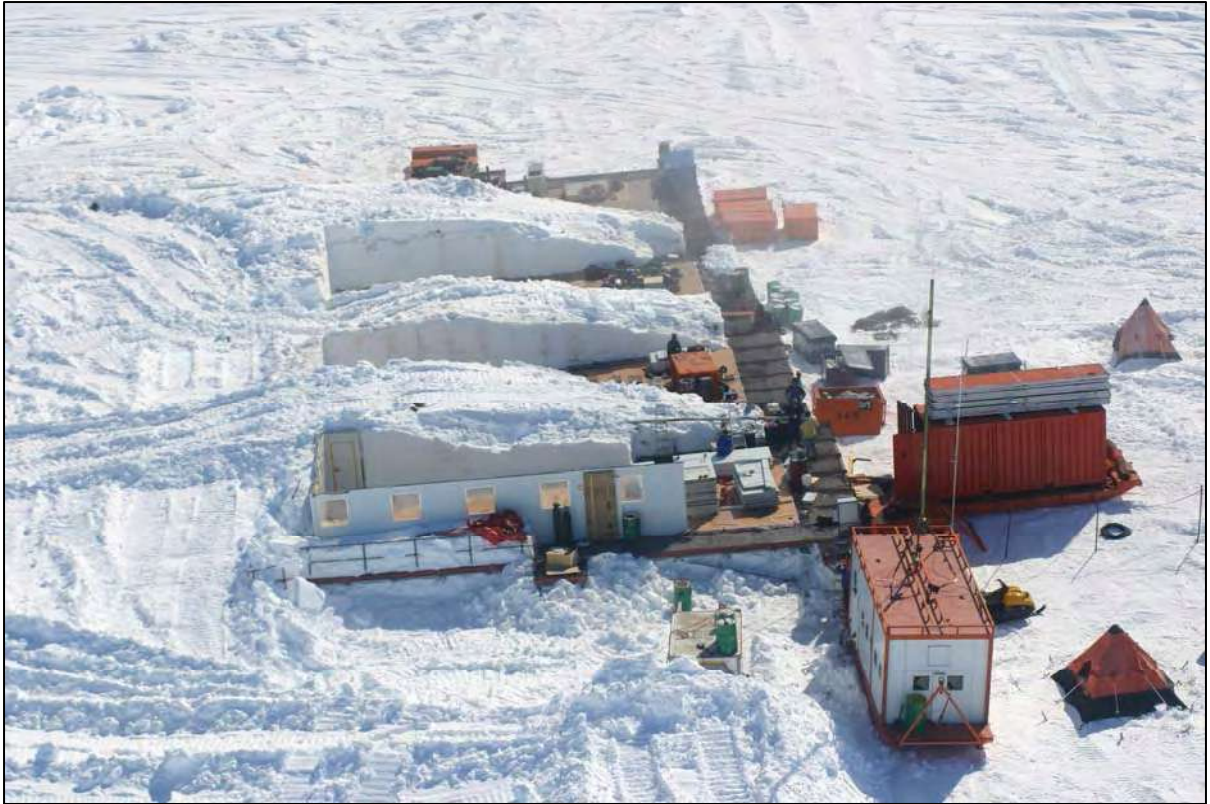
Photo 23 – 5th January 2006

Aerial photo of the last structure remaining. The insulated panels were removed by mid afternoon. Prior to the team being moved to the vessel a clean-up effort was held to collect any small debris that might have landed onto the ice or in the operating areas of the vehicles. The entire area was rehabilitated.

- All movable furniture, stoves, deep freezers, blower ovens, fixtures, electrics, piping and dry walls were removed from the lounge, dining room, pantry and kitchen area.
- All abovementioned items were packed into 20-foot transport containers.
- The decommissioning team started removing the insulated roof panels.
- The team continued by dismantling the walls and remaining support pillars (illustrated in photo 12).
- All metal waste (e.g. roof bolts, railings, PVC piping etc) was placed in recycle bins.
- Only the wooden floor panels and the steel support structures (space frame) remained behind.

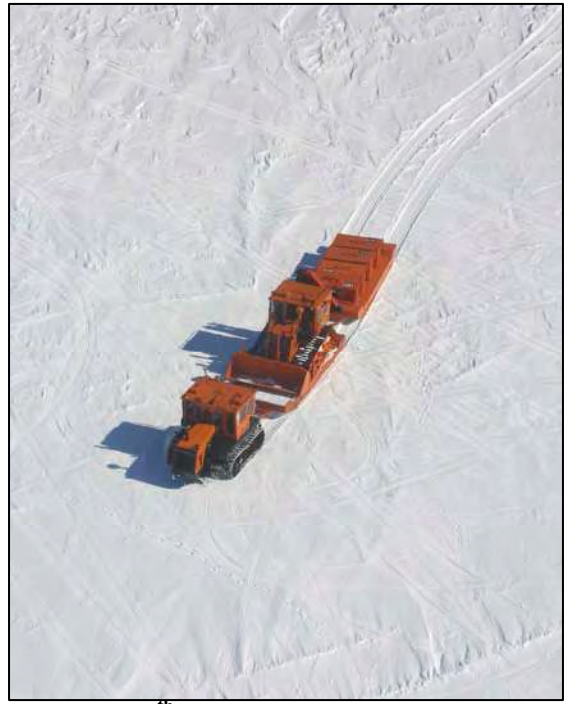
Photo 25 – 5th January 2006

Cargo being transported for back loading.

The back-loading was commenced on 13 January 2006. All building material, twenty-foot containers and panels were back loaded through a ramp onto the SA Agulhas. All cargo was back loaded and nothing remained depot on sledges.

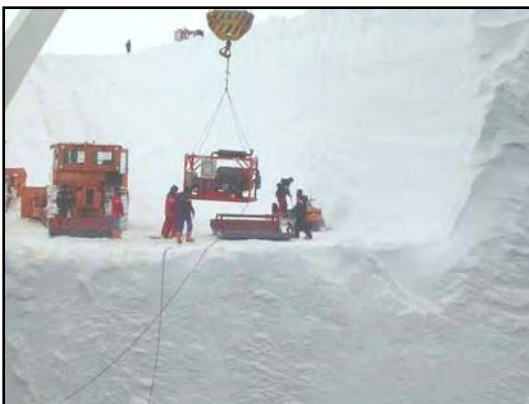
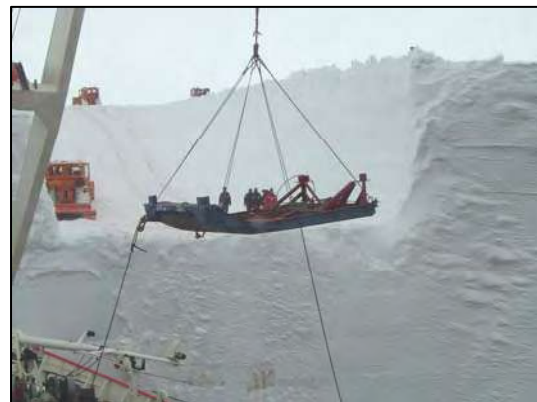
Photo 26 – approx 17th January 2006

The two illustrations above show the back loading through the ramp at the RSA Bukta.

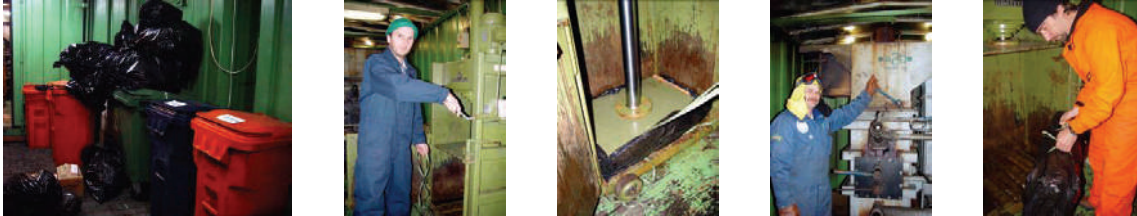
Figure 3: Photographs of waste management activities

All waste apart from food waste, sewage and grey water are removed from Ferraz for recycling or safe disposal in Brazil. Waste is separated at source in the following categories: Waste oil and lubes; paper; glass; metal; plastic; steel/aluminium cans; clothes; fluorescent lamps; and general waste. Waste bins are clearly marked by category.

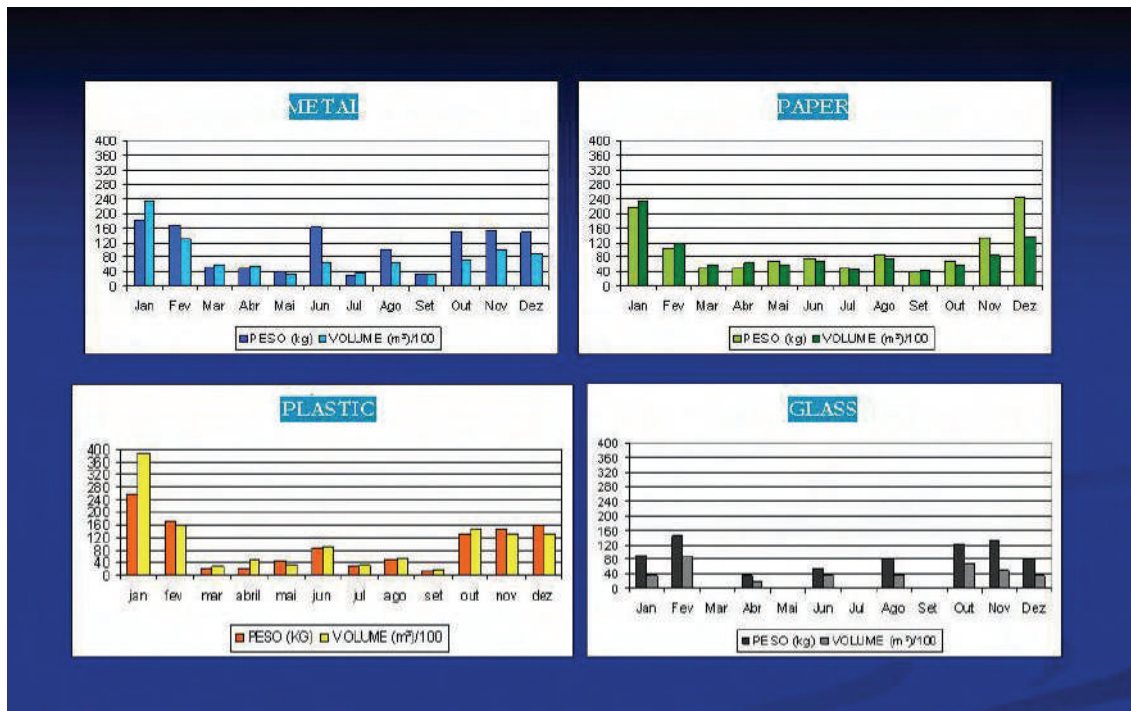
A study has been undertaken on the main categories of waste. The figure below shows waste generation.

Figure 4: Waste generation

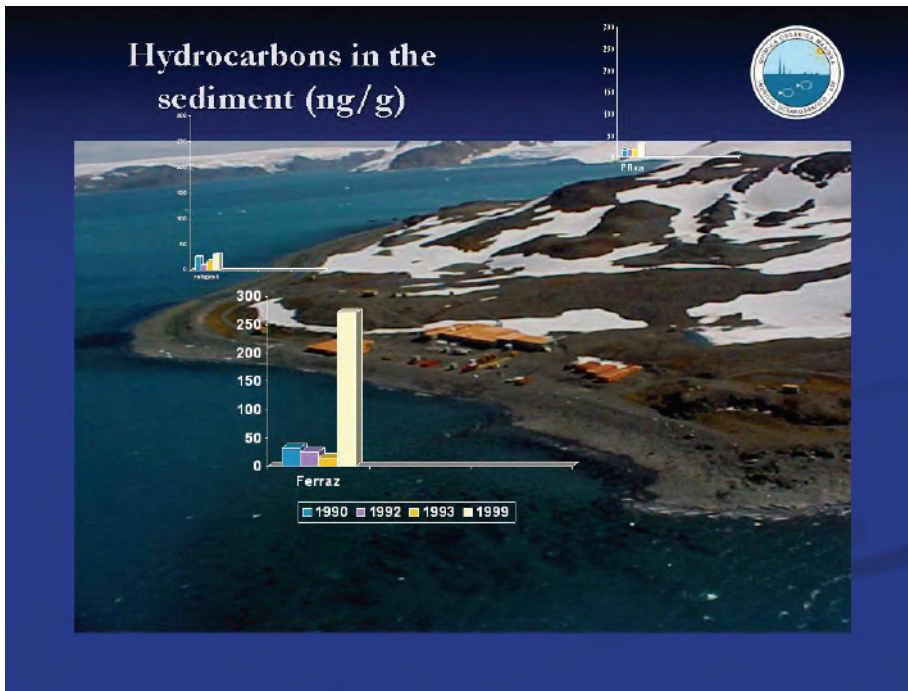
Figure 18:
Hydrocarbons in the sediments

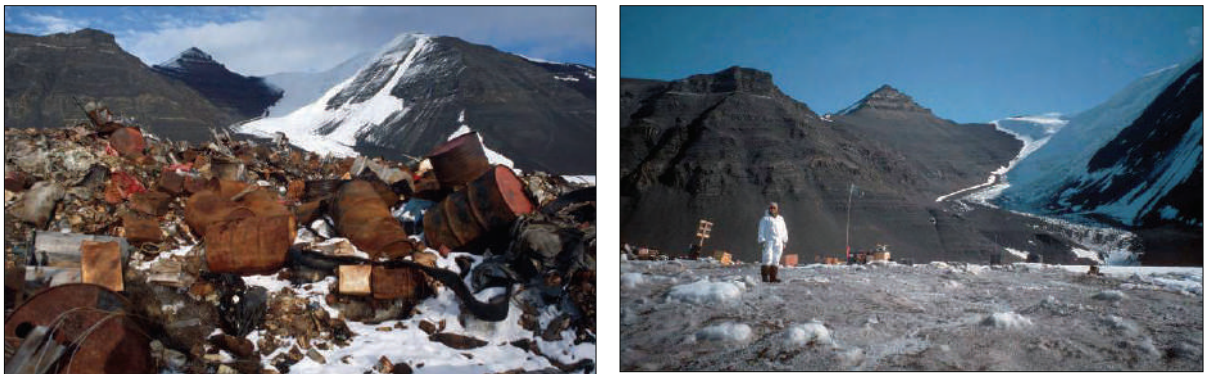
Figures 3 and 4: Fossil Bluff in Feb 2002 and following clean up in Feb 2003

During the Fossil Bluff clean-up, which resulted in an international “Green Apple” Gold Award in 2003, the following activities were carried out:

- The clean-up and removal of the old rubbish dump;
- The removal of hundreds of empty fuel drums, tins and general rubbish; and
- A total of over 50 tonnes of wastes were flown out.

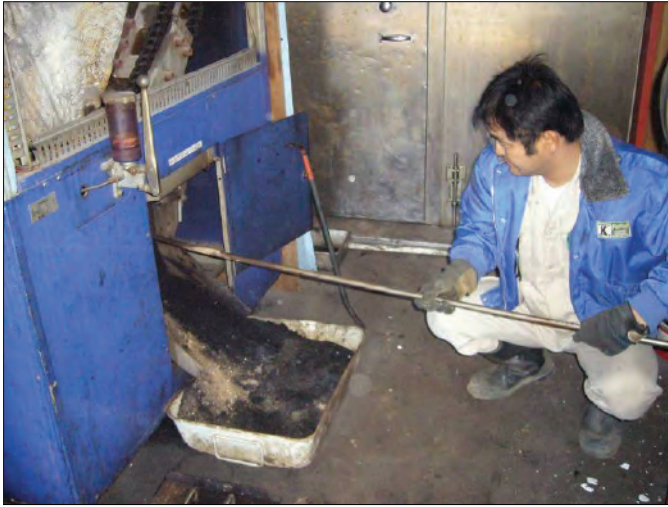
Figure 3: Carbonized charcoal from outlet

Prior to the installation of the carbonization instrument, an incinerator with an oil burner was used, but it was impossible to successfully burn a lot of garbage, especially at the end of the winter. Therefore, we decided to introduce a carbonization instrument to deal with food scraps.

Specifications for Carbonization Instrument	
Dimension (mm)	1510×1100×2090
Weight (kg)	1000
Capacity	0.2 m ³ /batch
Power supply	3 φ 200V AC
Power consumption	1.1kW
Fuel consumption	0.003 ~ 0.004 m ³ /h
Calorific value of burner	19,200 kcal/h
Operation time	4 ~ 6h/batch

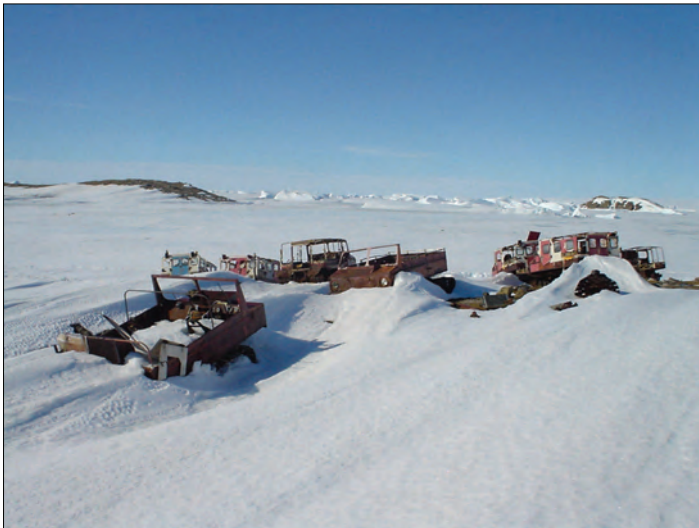
Figure 4 Waste snow vehicles and sledges around Syowa Station

Items of remaining wastes at Syowa	Weight (ton)
Snow vehicles, trucks, sledges	120
Scrap such as steel pipe	100
Empty fuel drums	12
Building materials	73
Instruments for scientific observation	22
Waste oil (lubricant, antifreeze) in drums (50 cans)	10
Total	337

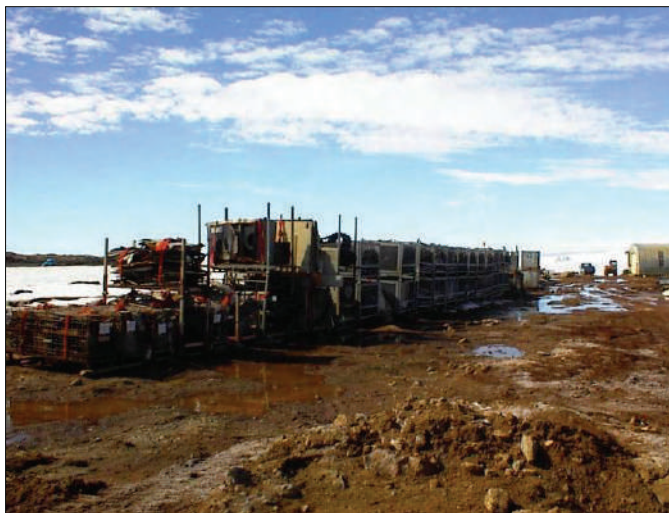
Figure 6: Waste packed for return to Japan

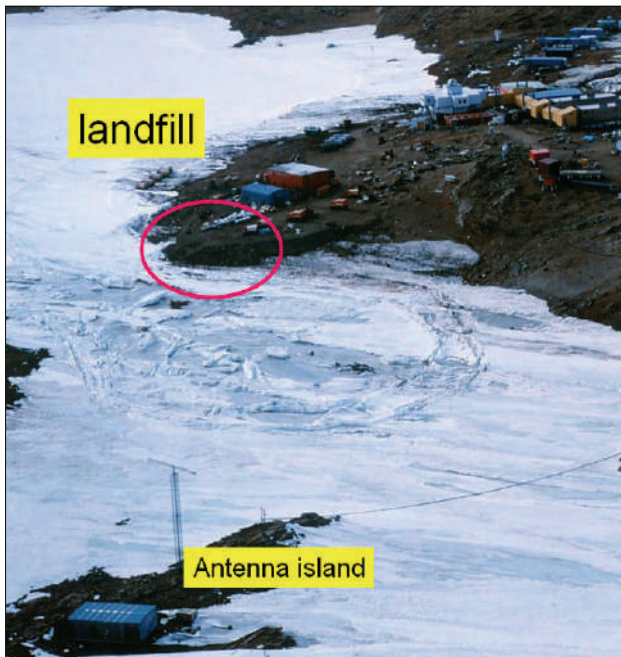
Figure 9: Landfill at Syowa Station

From 2009, we intend to start a clean-up program for the landfill at Syowa Station.

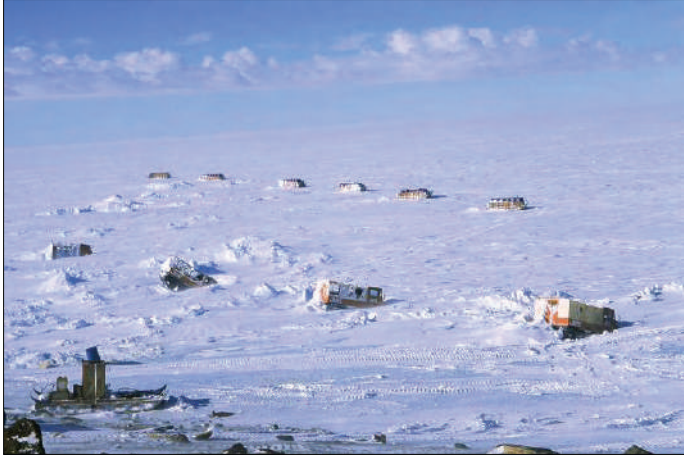
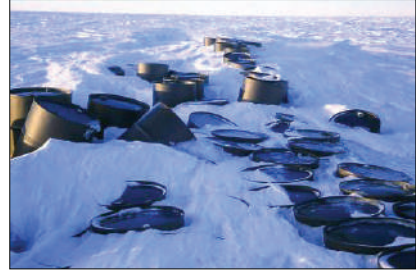
Figures 9 and 10: Waste snow vehicles and fuel drums at Asuka Station

Waste remains at the inland Asuka Station, which was inhabited by wintering parties over five years from 1987 to 1991. Asuka Station is located at approximately 71.5° South and 24° East. With an altitude of 930m, the annual average air temperature is -18.3°. The annual average wind speed is 12.6 m/s, while the wind direction is East-South-East.

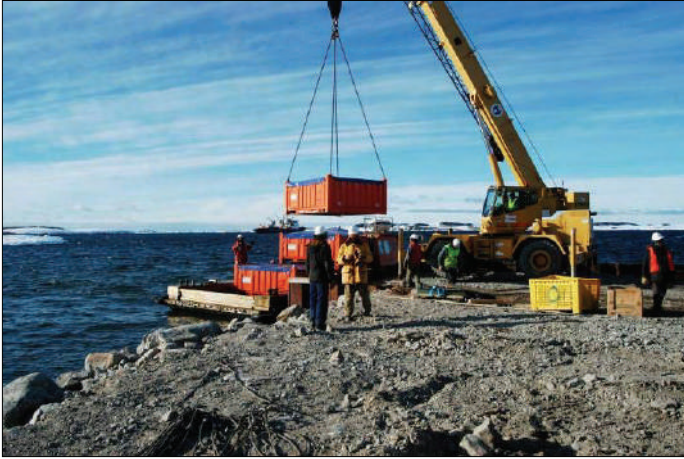
Figure 3: Loading the last container of waste from the tip in 2003-04

Over 1000 cubic metres of contaminated waste were loaded into special containers and returned to Australia for safe disposal. At least 1000 cubic metres remains stockpiled on the Thala Valley tip site, protected from meltwater by diversion channels, a geofabric/membrane barrier and bunding. Monitoring has been undertaken over the last two seasons to determine the effectiveness of these measures.

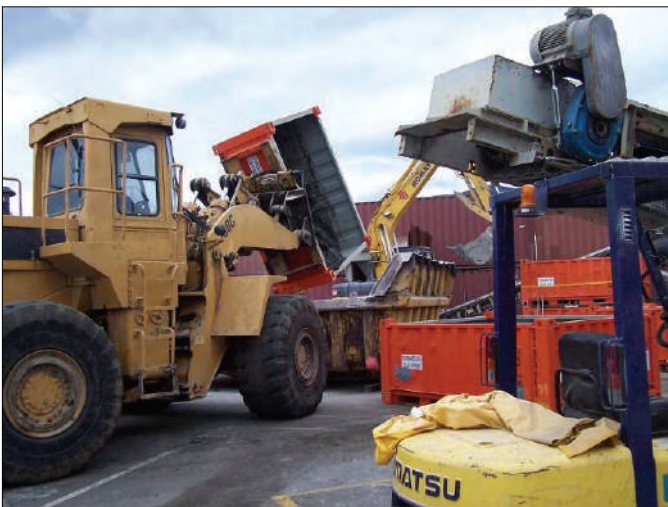
Figure 5: Loading remediated waste for transport to safe disposal site

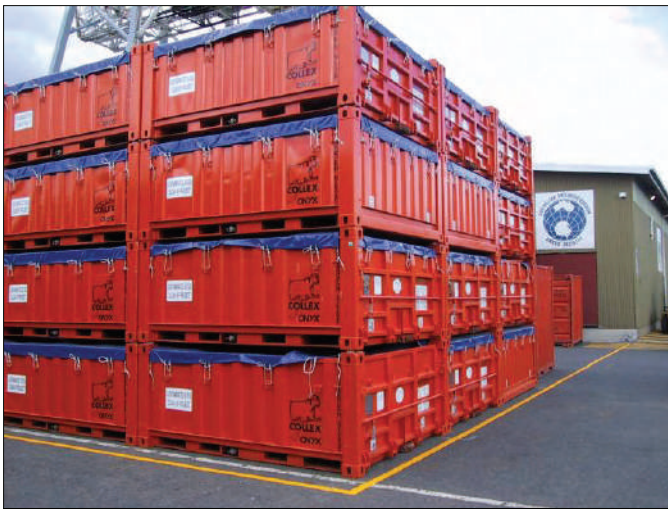
Figure 4: Waste Containers provided by Veolia Environmental Service for use at Thala Valley

The main philanthropic commitment from Veolia Environmental Services was the supply of 240 purpose-built waste containers to ship excavated waste back to Australia. The value of this commitment was \$2 million AUD.

By arrangement, these bins are available for use by other countries should the need arise.

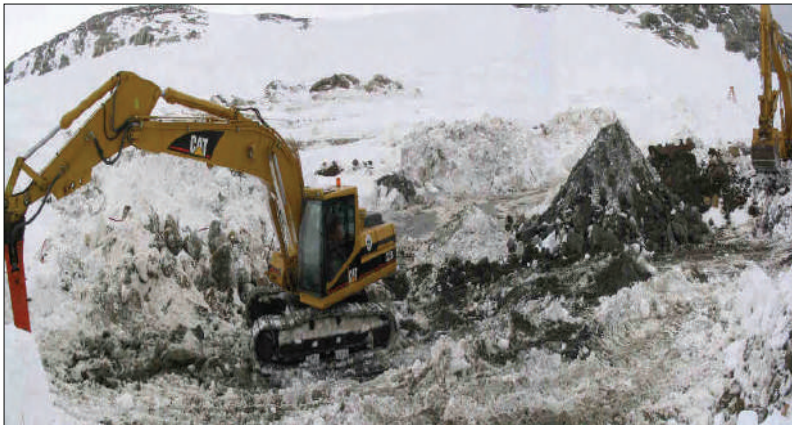
Figure 6: Excavation of frozen waste from Thala Valley

After several years of planning and preparation, excavation work began early in the 2003/04 summer season. Diversion channels were constructed to guide meltwater into Thala Valley around the excavation site. Sediment barriers and holding ponds were made so that water could be treated before being released to Browns Bay. All vehicles went through wash down before leaving the site. The 'tip team' wore personal protective equipment and observed safety procedures.

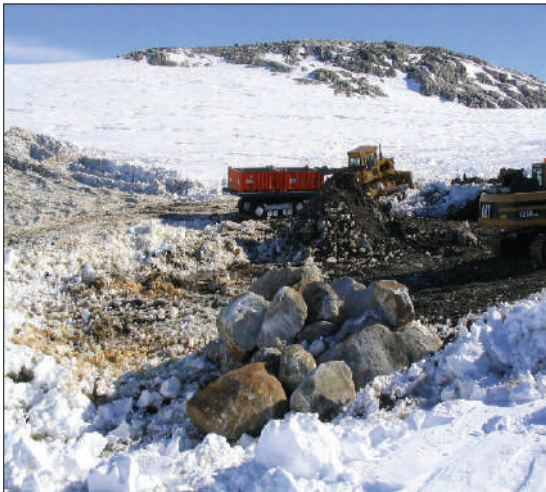
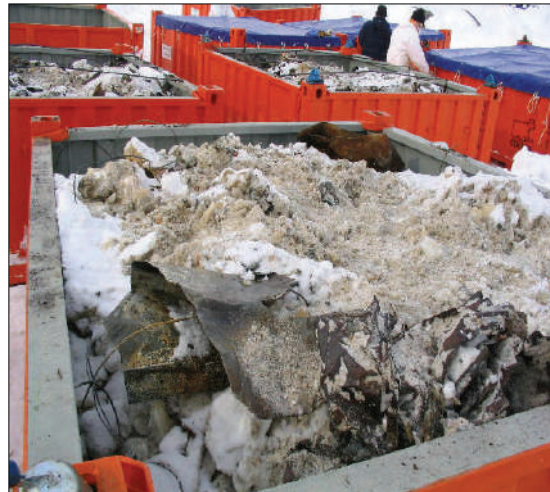
Figures 7 and 8: Excavation Site and Frozen Wastes in Container

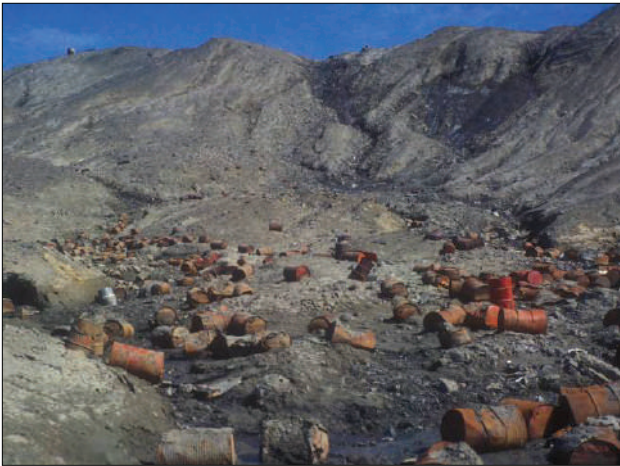
Figure 2: Wastes around Marambio Station

Since its foundation, intense logistic activities at Marambio Station have generated a significant amount of waste. During the first two decades of operations, wastes were disposed of on-site. Waste accumulated over the surrounding areas, forming large outdoor rubbish tips, resulting in a slow but continuous accumulation of negative effects, mainly on the landscape around Marambio. Some of these wastes, scrap and other residues, accumulated near the station, while others, particularly fuel drums, were transported away from the area of the station by gravity force, hydraulic action and backward erosion. Eventually, some of the drums reached the shoreline, after sliding through valleys and gullies.

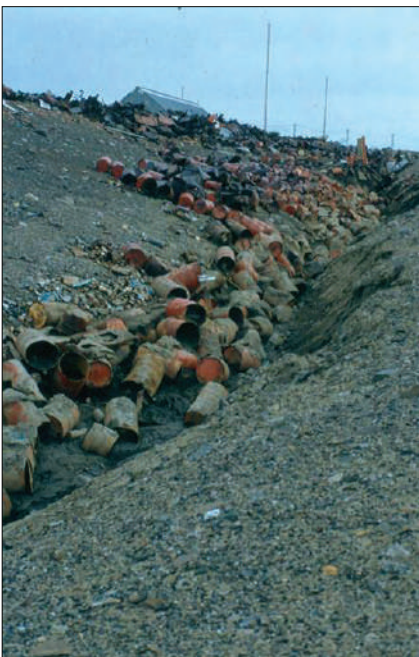
Figure 3: Wastes around Marambio Station

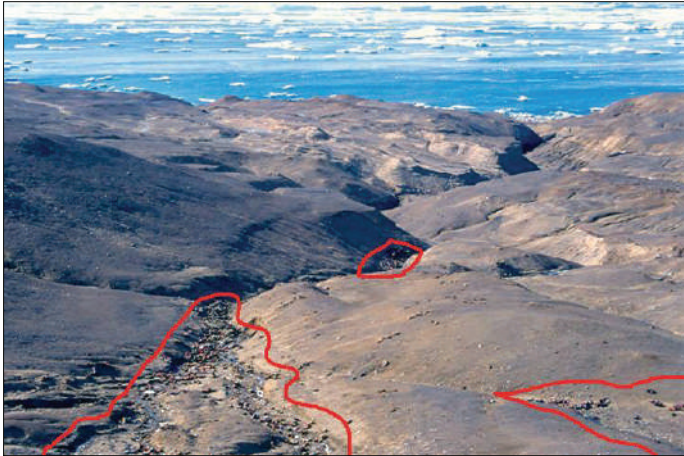
Figure 4: Before clustering activity

Thanks to the clean-up activities, more than 20 waste deposits have been completely removed. This accounts for more than 50% reduction in the volume of old waste deposits around Marambio Station. In addition, waste classification and clustering activities have been undertaken in some other areas to facilitate removal in the future.

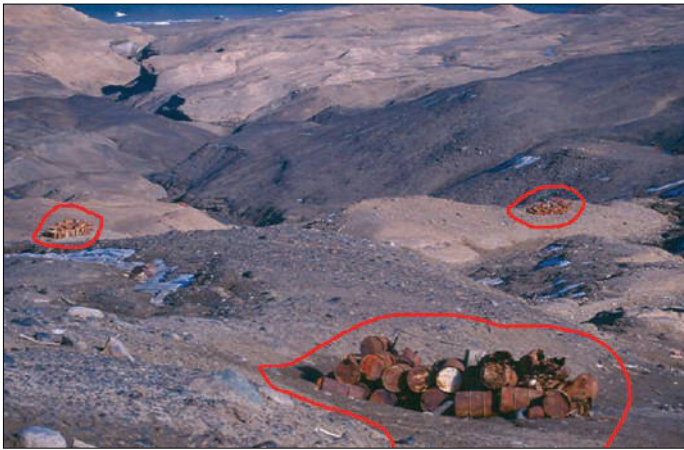
Figure 5: After clustering activity
