Waste Management in Antarctica

2006 Workshop Proceedings

Proceedings of the 2006 workshop held by the
COMNAP Antarctic Environmental Officers Network (AEON)
on Monday 10 and Tuesday 11 July 2006

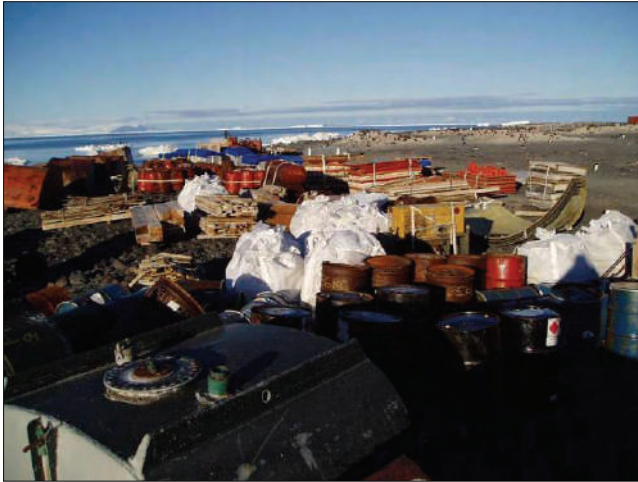
Figure 6: 2003 / 04 clean up efforts

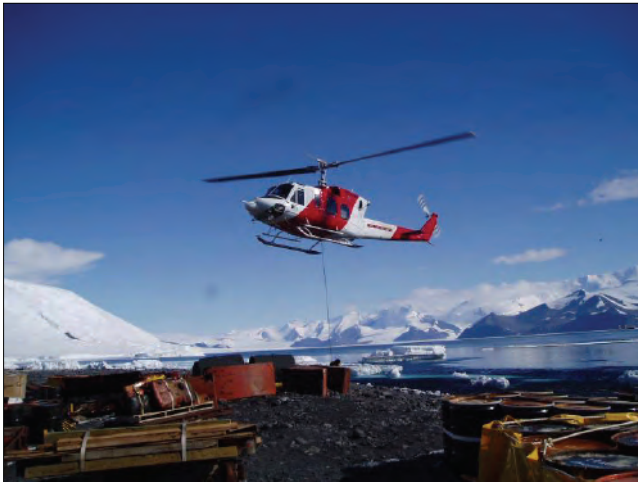
Figure 7: 2004 / 05 clean up efforts

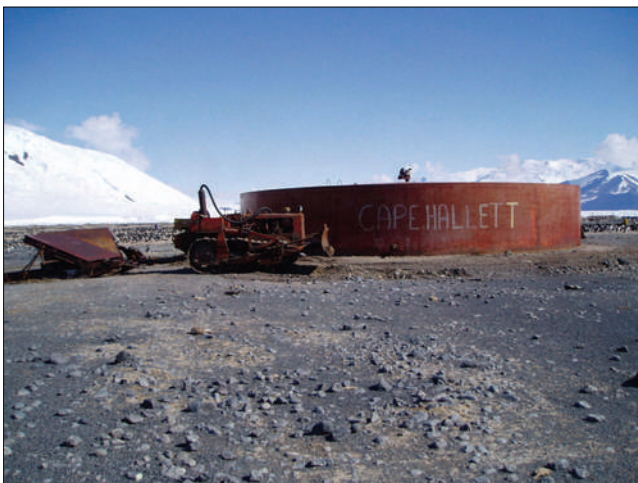
Figure 8: Tank removal occurred 2005 / 06.
